Utah Water Research Laboratory
UtahStateUniversity

Water Main Break Rates in the USA and Canada: A Comprehensive Study

December 2023

A Resource to Support Asset Management,
Pipeline Renewal, and Replacement

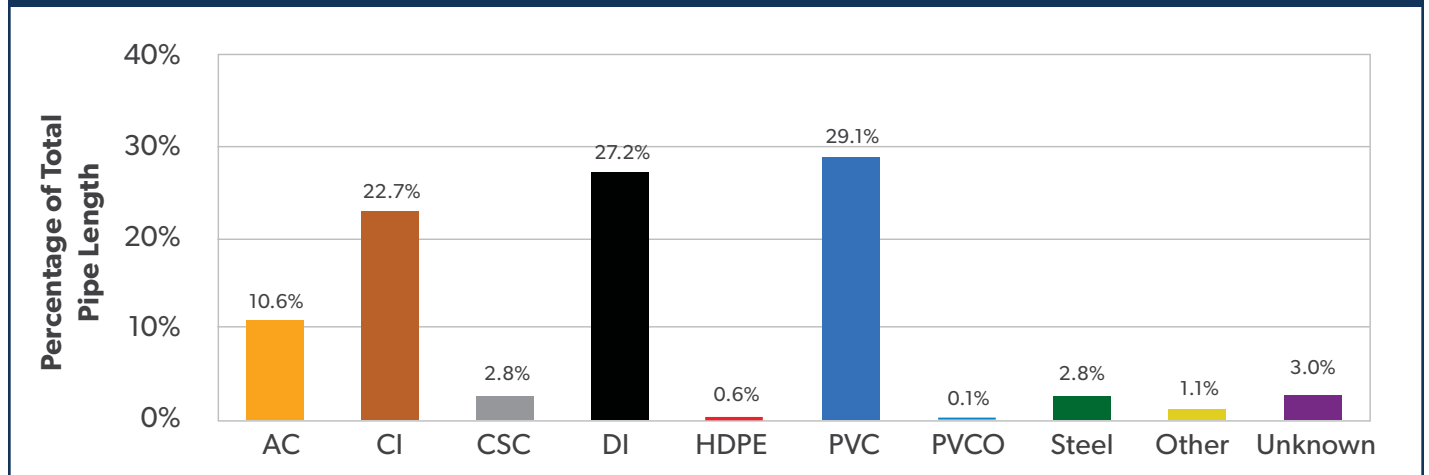
FIGURE 13: PERCENTAGE OF PIPE LENGTH BY MATERIAL TYPES (BASIC SURVEY)

Figure 13 illustrates the percentage of total length of water mains by pipe material. It is significant to consider that nearly 90% of the water mains reported are made from cast iron (CI), asbestos cement (AC), ductile iron (DI), and polyvinyl chloride (PVC) materials. This is consistent with earlier USU studies (Folkman, 2012; 2018). The EPA provides a summary of the timelines of when these materials have been in use: *The majority of distribution piping installed in the United States, beginning in the late 1800's up until the late 1960's, was manufactured from cast iron... referred to today as "pit" cast iron pipe. ...In 1920, the process of centrifugally casting pipe in a sand mold was introduced... referred to as "spun" or "centrifugally" cast iron pipe (which was commonly installed until the 1970's). Asbestos cement became commercially available in the 1930's and was commonly installed during the 1950's and 1960's. Following this was the introduction of ductile iron pipe in the late 1960's. Shortly after the introduction of ductile iron, the use of ... polyvinyl chloride (PVC) ... in this country began to emerge in the 1970's (EPA, 2002).*

As shown in Figure 13, the percentages for the installed CI and AC pipe in 2023 are 22.7% and 10.6%, respectively. Figure 13 also illustrates that PVC has the highest percentage of all pipe materials at 29.1%, with DI pipe at 27.2%. As shown in Figure 14, in 2018 CI and AC pipe accounted for 28.4% and 12.7% of all pipe miles, respectively. The combined inventory for these two materials in 2018 was 41.1%, and 33.3% in 2023. This represents a decrease of 7.8%. During the same 5-year period, PVC pipe length increased by 7.0% and DI remained approximately the same. It is noteworthy that the reduction in CI and AC is similar to the increase in the installed length of PVC pipe.

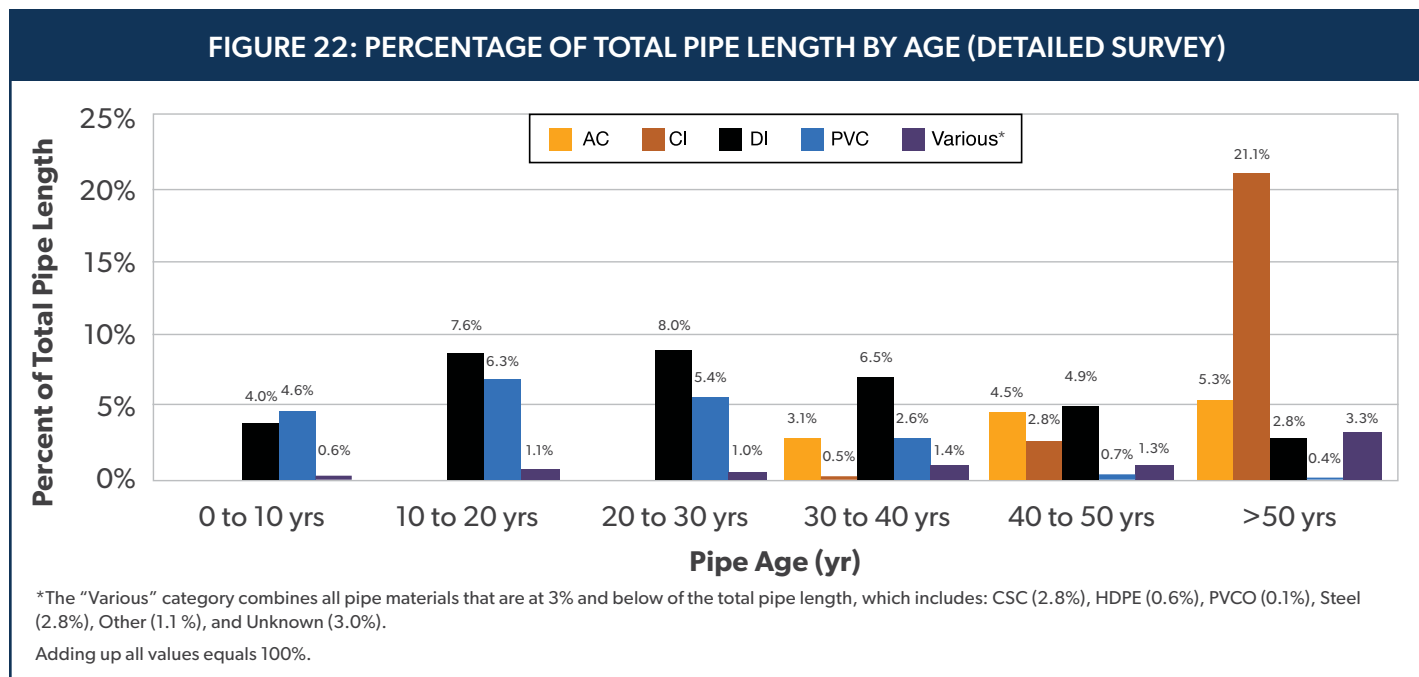
Figure 22 shows the age distribution as a percentage of the total length of all pipe materials from the detailed survey. For example, CI older than 50 years is 21% of all installed pipe. For ages between 0 to 10 years, DI and PVC both have about 4 to 5% of the total installed length. This means that the most common pipe materials installed over the last 10 years are DI and PVC.

Of the reported cast iron pipe, 86% is over 50 years old. Similarly, 41% of asbestos cement pipe is over 50 years in age. Interestingly, break rates for both materials have decreased since 2018 (cast iron by 18% and asbestos cement by 1%). It appears that since cast iron and asbestos cement pipes are no longer manufactured and are reaching the end of their expected lives, these legacy pipe materials are being proactively replaced.

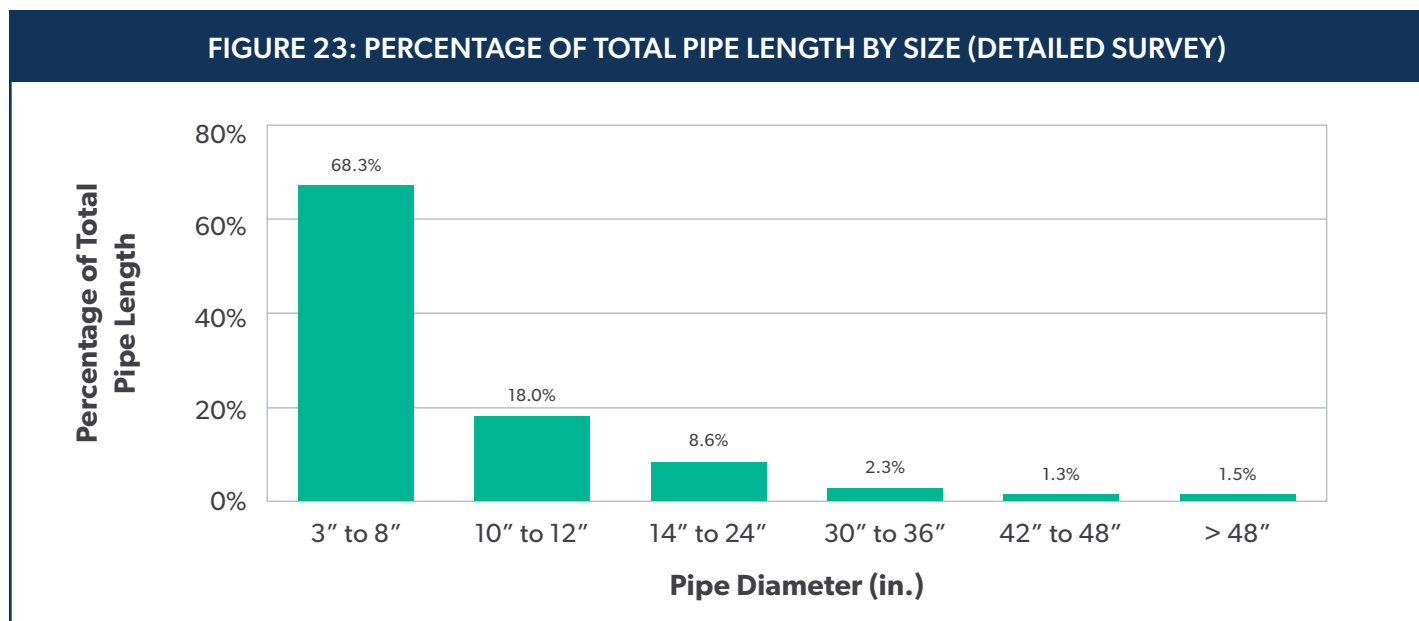
PIPE DIAMETER. The detailed survey respondents were also asked to break down the total installed pipe length by six pipe diameter categories. Figure 23 illustrates the percentage of pipe divided into each size range. Figure 23 indicates that approximately 68% of installed pipe is 8-inch or smaller, and 86% is 12-inch or smaller. In comparison, the 2012 and 2018 USU surveys found that 66% and 67% of the pipes were 8-inch or smaller, respectively. This demonstrates consistent pipe size usage and validation of data accuracy (Folkman, 2012; 2018).

Based on EPA's estimate of 2.2 million miles of water pipe in the US, these sizes equate to roughly 1.9 million miles of pipe in the US. Similarly, using Statistics Canada's estimate of 133,000 miles of water pipe, it is estimated that roughly 115,000 miles of pipe in Canada is between 3- and 12-inch in diameter.

This study found that 68% of water mains are 8-inch diameter or smaller and that 10- to 12-inch sizes add another 18%. Based on EPA's estimate of 2.2 million miles of water pipe in the US, these sizes equate to roughly 1.9 million miles of pipe. Similarly, using Statistics Canada's estimate of 133,000 miles of water pipe, it is estimated that roughly 115,000 miles of pipe in Canada is between 3 inches and 12 inches in diameter.

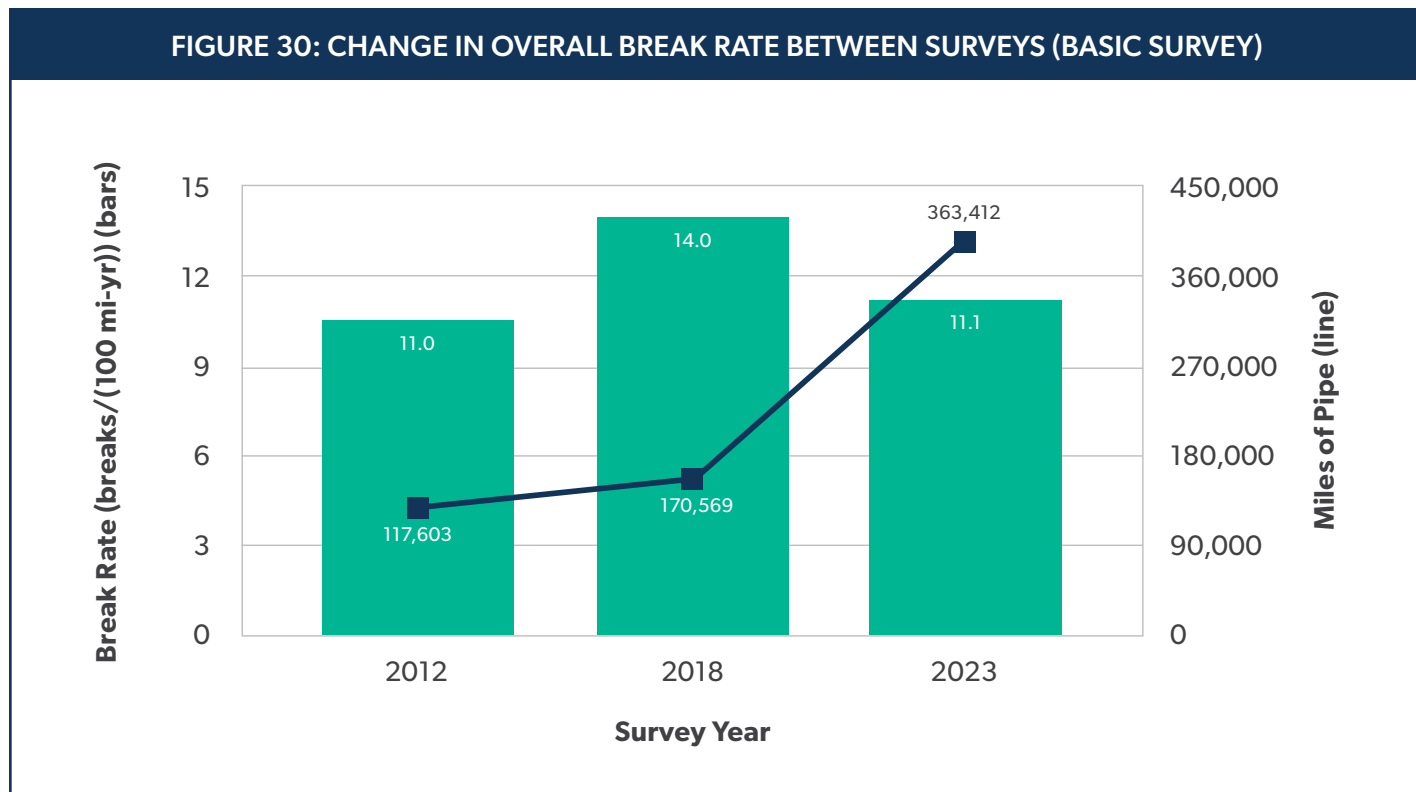
Figure 30 illustrates the overall reported break rates from this survey and the two previous reports (Folkman, 2012; 2018). It is apparent from the figure that the current survey represents a significant number of pipe miles. Even with this large sample size, the overall break rates are relatively consistent with only a slight reduction in failure rates in the last six years. This decrease may indicate that more utilities are applying asset management techniques and replacing pipe with the highest break frequency.

While break rates have remained consistent for most pipe materials over the last decade, overall water main failures between 2018 and 2023 decreased by 20% from 14.0 to 11.1 breaks/(100 mi-yr). This decrease seems to correlate with reduced inventory of cast iron and asbestos cement pipe (both of which have the highest failure rates).

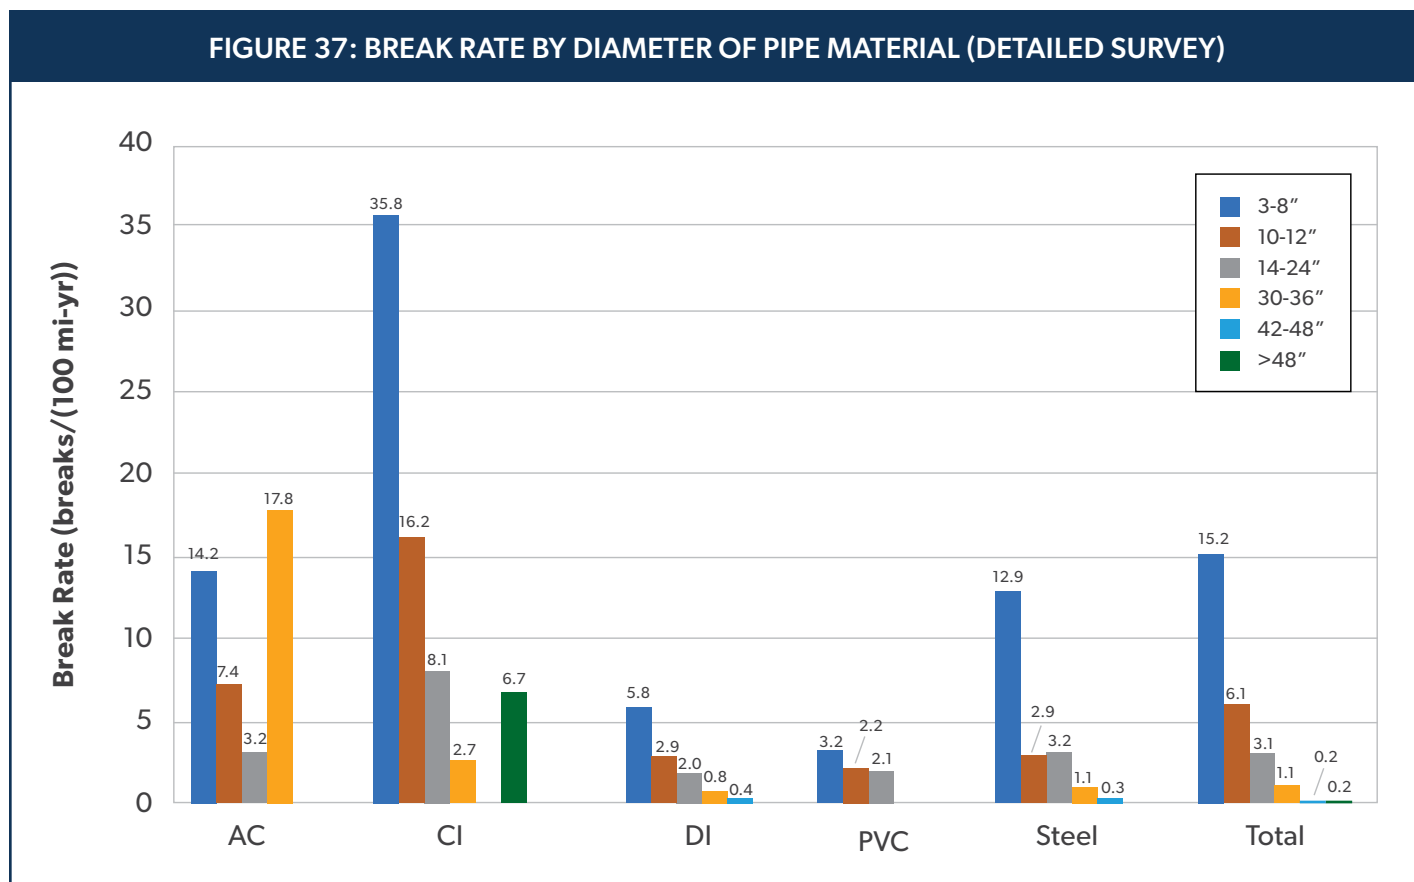
The detailed survey asked utilities for information on the size of different pipe materials in their water systems and their corresponding break rates. Figure 37 illustrates how the break rate changes as a function of pipe diameter. It is noteworthy that the break rate for all materials decreases as pipe diameter is increased. This is likely because of the greater effort put into installing, maintaining, and monitoring larger diameter pipes due to a higher consequence of failure. The higher break rates in larger diameters for AC and CI pipe are likely due to the low number of miles for these materials in this survey.
